approach

APRIL 1978 THE NAVAL AVIATION SAFETY REVIEW

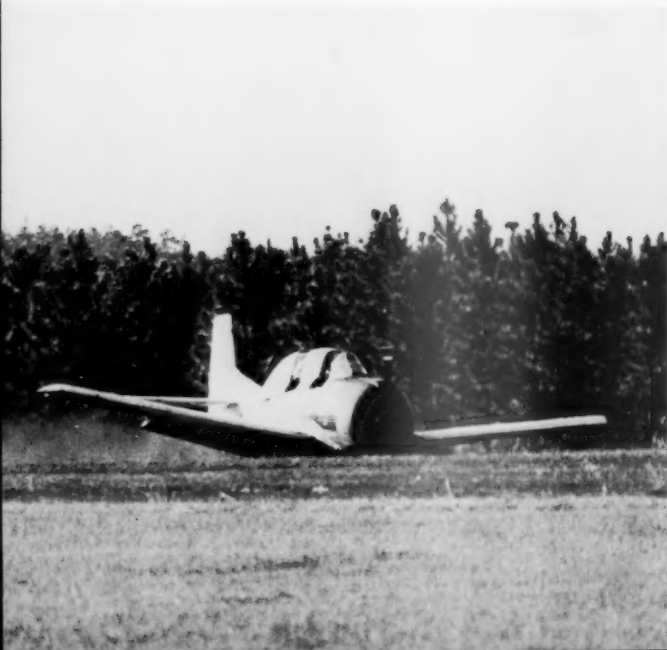
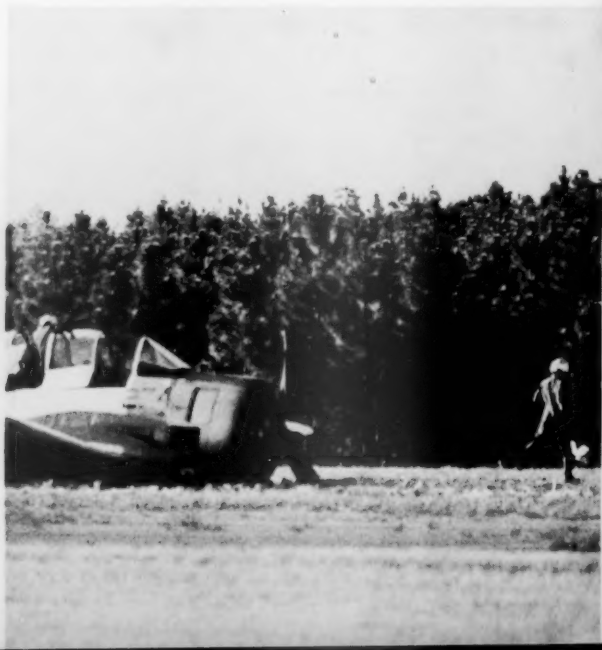
LTJG Marlette executed a waveoff and climbed to 3500 feet. For the next hour and a half he tried everything in the book, plus a few other acts, to lower the gear handle. It not only was in the UP position, but also seemed to be bolted there.

It was recommended — long ago — by the greatest minds in aviation maintenance to get rid of Murphys forever by making a one-time inspection of all T-28s to ensure that all bolts were installed correctly. As a further precaution, a written warning was placed in NAVAIR 01-60FGB-2, telling the world that if the bolt is installed backwards, the landing gear will not come down!

*Murphy's Law says: If an aircraft part can be installed incorrectly, someone will install it that way.

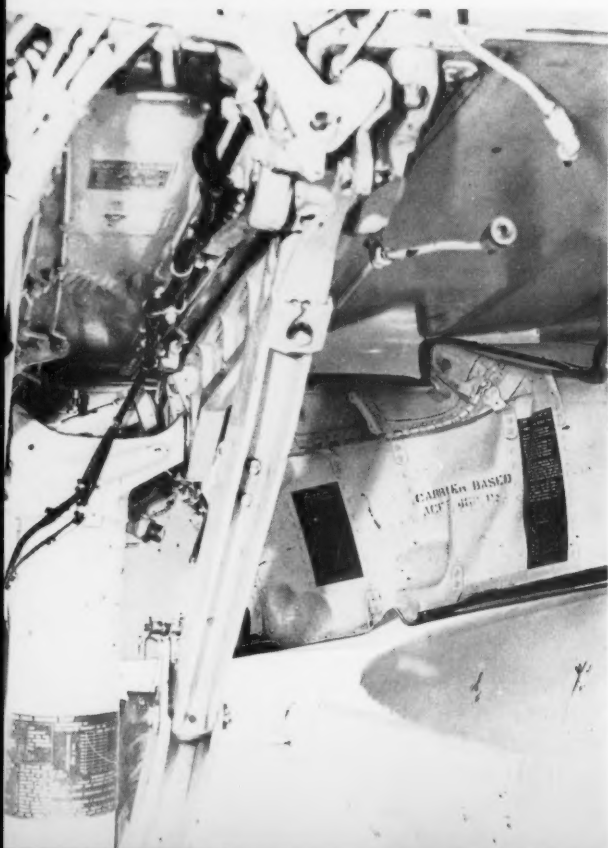
This brake hose frequently catches on some part of the wheelwell when the strut deflates.
